# **Natural Conditions Assessment for Low pH, Hoskins Creek and Tributaries in Essex County and Town of Tappahannock, Virginia**

**Submitted by  
Virginia Department of Environmental Quality**

**May 2010**

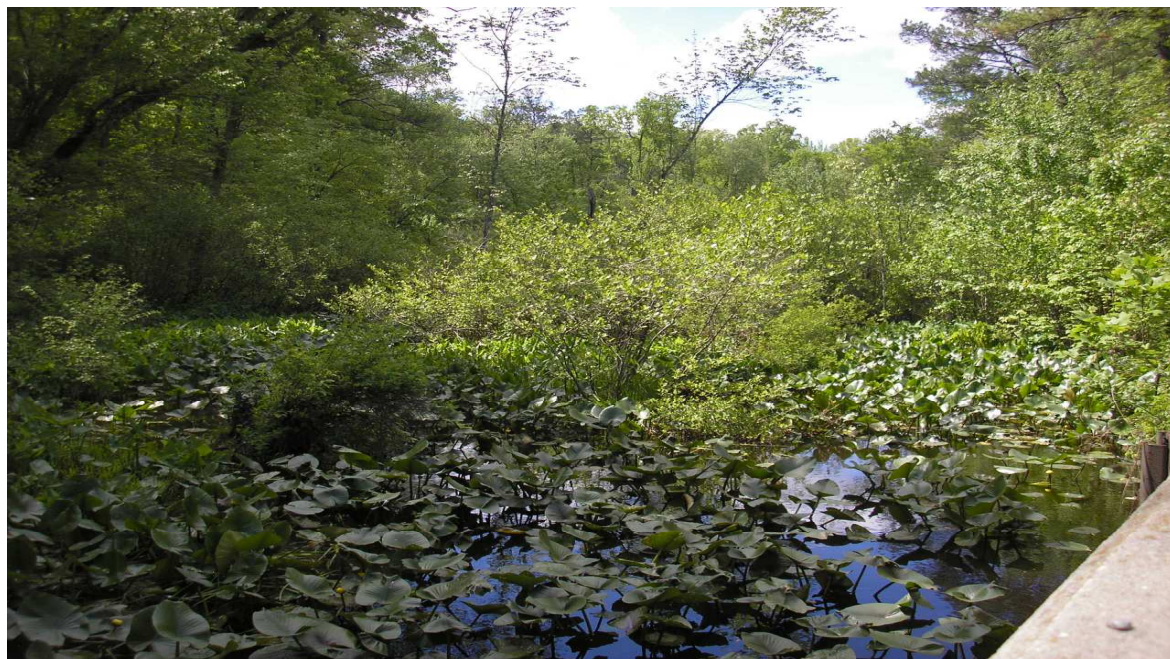
**Figure 12. Hoskins Creek, Rt. 620, Upstream.**

Visual inspections of Hoskins Creek and tributaries revealed swampy areas with heavy tree canopy. Decomposition of vegetative matter from large swampy areas lowers DO and pH as decay occurs. (Figures 12-14). See the title page photo of tidal Hoskins Creek showing heavy marsh between the head of tide and the confluence of Church Swamp.

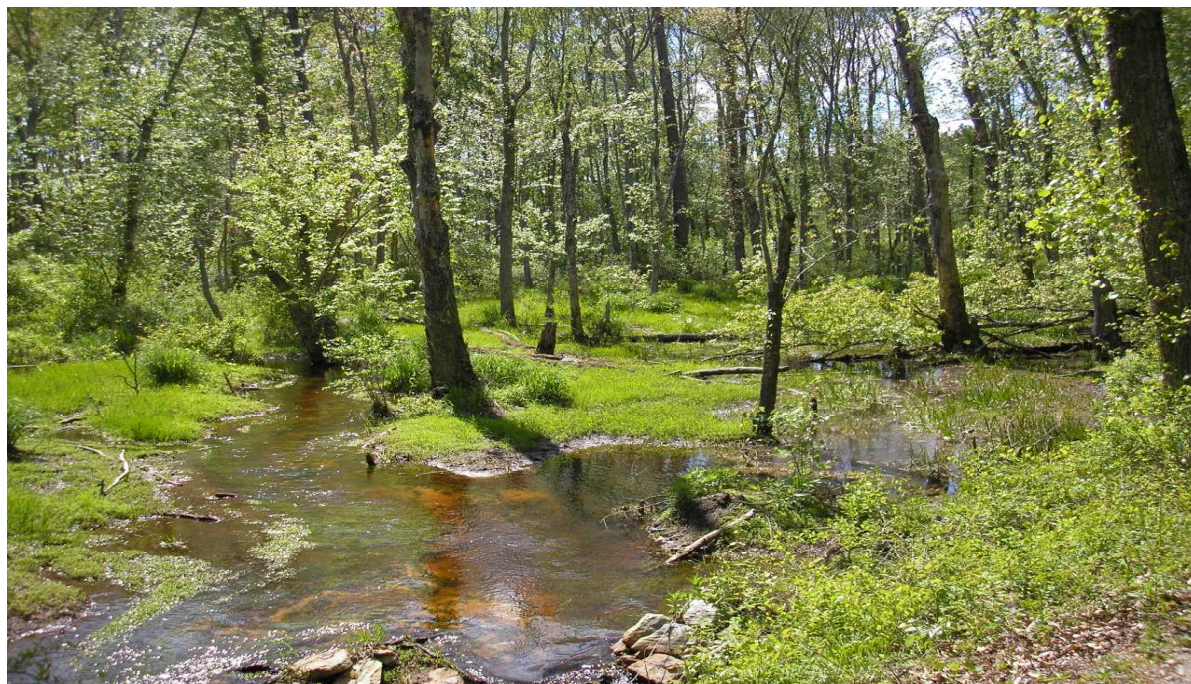
**Figure 14. UT XGY to Hoskins Creek, Rt. 620, Upstream.**
